Central Police Station Revitalisation Project Restoration of the Historic Buildings

The Principles

The Facades

The Roofs

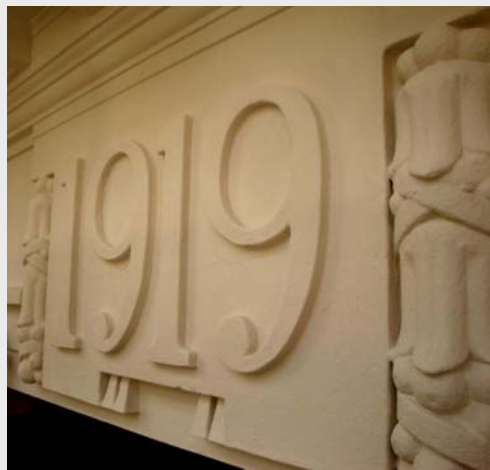
The original beige colour is restored to the exterior wall of the Police Headquarters Block

The façades were restored generally to their original colours (or natural brick surfaces, as the case may be) or the earliest traceable major renovation. This means that some of the restored buildings have colours that are different to those at the time of site decommissioning in 2006. In the case of the Police Headquarters Block, for example, the north façade was restored from a dull grey to beige.

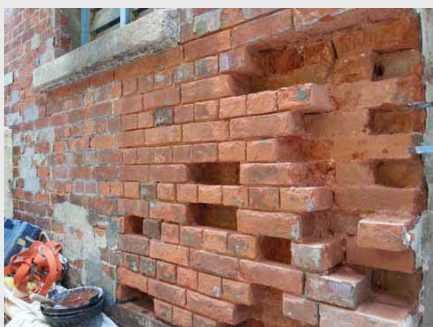
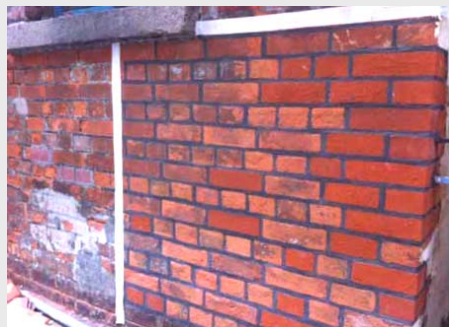
One of the effects of paint removal was the uncovering of old defects in the rendering which had previously been hidden by the paint layers. These had to be repaired before repainting could go ahead. In some cases the defects were confined to unstable layers of filler no more than 1mm thick, to sections of the original render, which had to be carefully removed and replaced. Once these works were complete, a primer coat was applied to even out the effects of the various substrates – original, modern and new – before the new paint media could be applied.

A brick wall before and after repair

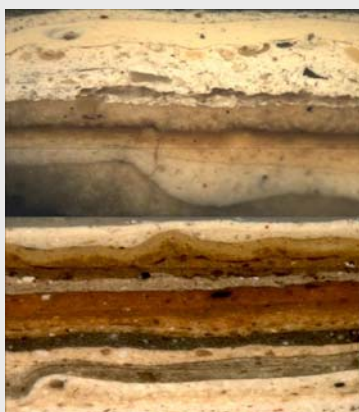
Examination of the paint layers showed that generally they were unstable and needed to be removed before re-painting could be carried out. This required consideration of how best to remove the layers without causing damage to the underlying substrate. A series of paint removal trials was carried out to find a method that was effective and practical. The outcome of the trials was to use a chemical paint stripper to soften the paint, leaving it overnight, and to remove the softened paint using high-pressure steam. The results were highly satisfactory, having removed the paint layers thoroughly but without causing damage to the underlying surfaces.

A microscopic view of multiple layers of paint with a total thickness of approximately 1.2mm on a wall surface at CPS

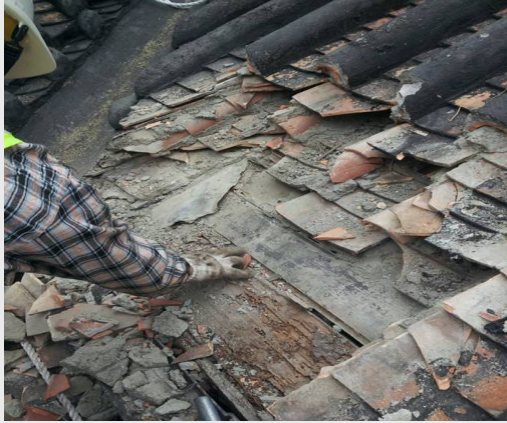
The condition of the tiled roofs varies, but all suffered from leaks and need to be re-tiled. To do nothing is not an option. In addition to providing improved weather-tightness, the re-tiling has enabled insulation and vapour barriers to be installed to counteract the risk of condensation and improve energy efficiency.

Rooftop in need of repair

For these reasons, in restoring the roofs, tiles are left in their natural terracotta colour and the tile rolls are finished with natural-coloured mortar. The appearance of the rolls is light grey but this will weather to a grey-brown over time, and the tiles can be expected to darken.

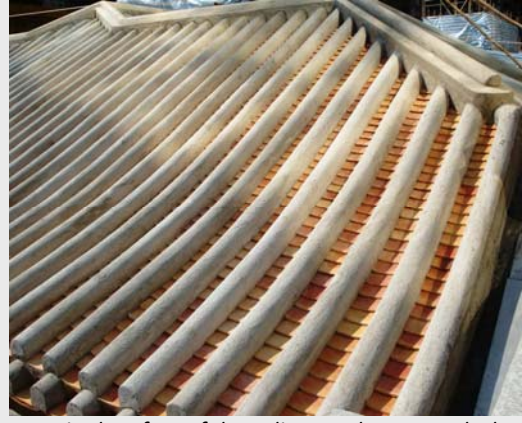
Repaired rooftop of the Police Headquarters Block

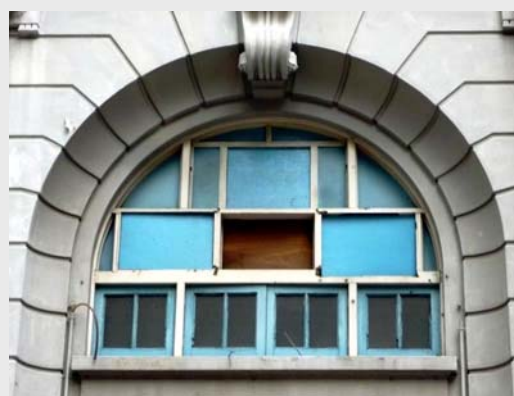
In modern times, the windows of the CPS buildings have been much altered to accommodate air-conditioner units. This has disfigured the appearance of the buildings and so threatened their architectural value. For this reason it is important that the windows are restored. It is also important that the restoration is authentic.

Bright blue was applied to the windows in recent decades

All the joinery items were itemised and recorded. These were then carefully removed from the buildings, stripped of the multiple layers of paint, and defective sections cut out and replaced. Where appropriate, broken glass panes were replaced. The joinery was then painted on the external surfaces, and finished with a clear varnish on the interior surfaces. Ironmongery for each door or

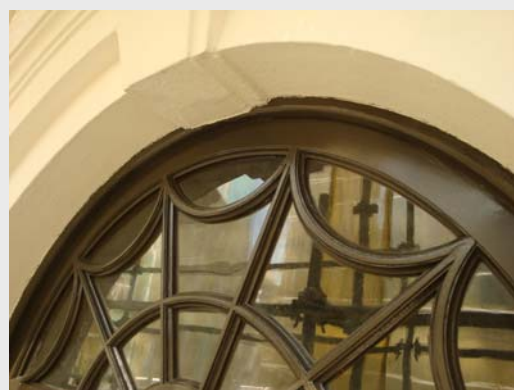
Dark brown was the original colour used for painting the windows

The paint analysis shows that the joinery at the Police Headquarters Block was originally painted dark brown externally. Whereas this may seem odd when applied to an expensive material such as Teak, it would guarantee a consistent external appearance, bearing in mind the different timbers used, and it would have been easier to maintain compared with a varnish finish. Internally, the finish was
