Central Police Station Revitalisation Project Restoration of the Historic Buildings

The Principles

The Facades

The Roofs

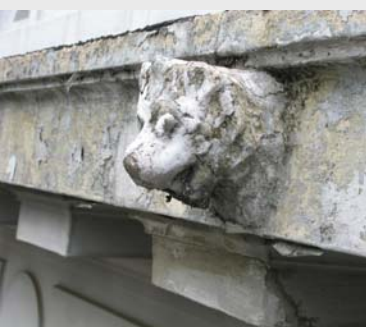
Examination of the paint layers showed that generally they were unstable and needed to be removed before re-painting could be carried out. This required consideration of how best to remove the layers without causing damage to the underlying substrate. A series of paint removal trials was carried out to find a method that was effective and practical. The outcome of the trials was to use a chemical paint stripper to soften the paint, leaving it overnight, and to remove the softened paint using high-pressure steam. The results were highly satisfactory, having removed the paint layers thoroughly but without causing damage to the underlying surfaces.

One of the effects of paint removal was the uncovering of old defects in the rendering which had previously been hidden by the paint layers. These had to be repaired before repainting could go ahead. In some cases the defects were confined to unstable layers of filler no more than 1mm thick, to sections of the original render, which had to be carefully removed and replaced. Once these works were complete, a primer coat was applied to even out the effects of the various substrates – original, modern and new – before the new paint media could be applied.
