Proposed Recovery Work for Block 4 at The Central Police Station Compound

PURPOSE

This Paper briefs Members of the Antiquities Advisory Board (AAB) on the proposed plan for the recovery of the Married Inspectors' Quarters ("Block 4") at the Central Police Station (CPS) Compound, which partially collapsed on 29 May 2016. This Paper follows a submission on eight initial options for the recovery of Block 4 to the AAB on 8 September 2016 (Board Paper AAB/33/2015-16) and a subsequent submission on three shortlisted options for the recovery of Block 4 to the AAB on 7 September 2017 (Board Paper AAB/15/2017-18).

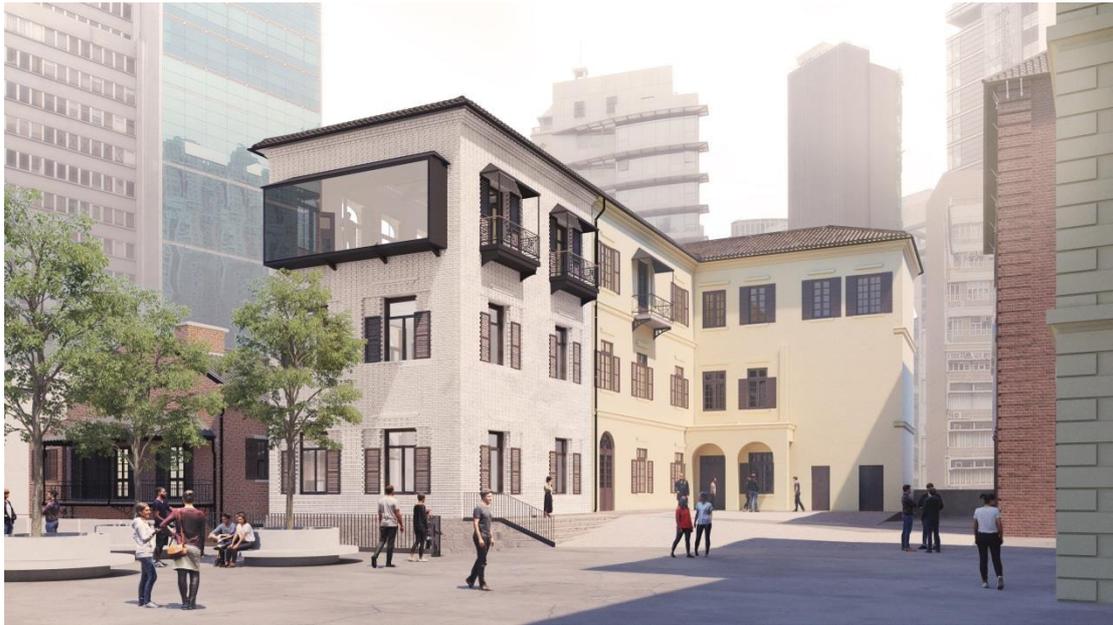
Image one: Architect's rendering of the recovered Block 4

In the proposed design, in order to maintain a high degree of compatibility between the new annex and the extant portion, the platform on which the building stands will be unaltered. The Chinese-style tiled roof will be extended from the extant portion to cover the new annex so that the old and new structures are clearly shown as one building. The windows and doors of the new annex will be opened along the same grid lines of the openings of the extant portion. The new annex will also have a brick facade as does the extant portion so that the two structures share very similar building

materials. Two decorative metal balconies, a key feature of Block 4, which were removed for storage after the partial collapse, will be reinstalled although strengthening will be required to ensure safety.

At the same time, visible yet modest design adjustments will be executed to differentiate the new annex from the extant portion. The facade of the new annex will be built with bricks made of materials of a lighter colour than the bricks of the extant portion, and the bricks will be oriented at an angle so that it is clear that the two structures were built at different times. The second-floor balcony facing the Parade Ground, which had been damaged many years ago, will be rebuilt with new materials to increase the transparency of the building, creating more possibilities for future activities. These adjustments will assist in differentiating the old and the new structures but emphasizing the linkages between the two.

The facade of the new annex will make strong references to the extant portion, including Character Defining Elements such as the layered rhythmic arches, balustrades, windows, shutters and balconies. These features have been carefully studied and interpreted in the new facade with functional considerations and contemporary expression.

An architect's rendering of the recovery design is attached in the Appendix as Image 1 and a rendering of the recovered Block 4 sitting in the heritage compound is attached as Image 2.

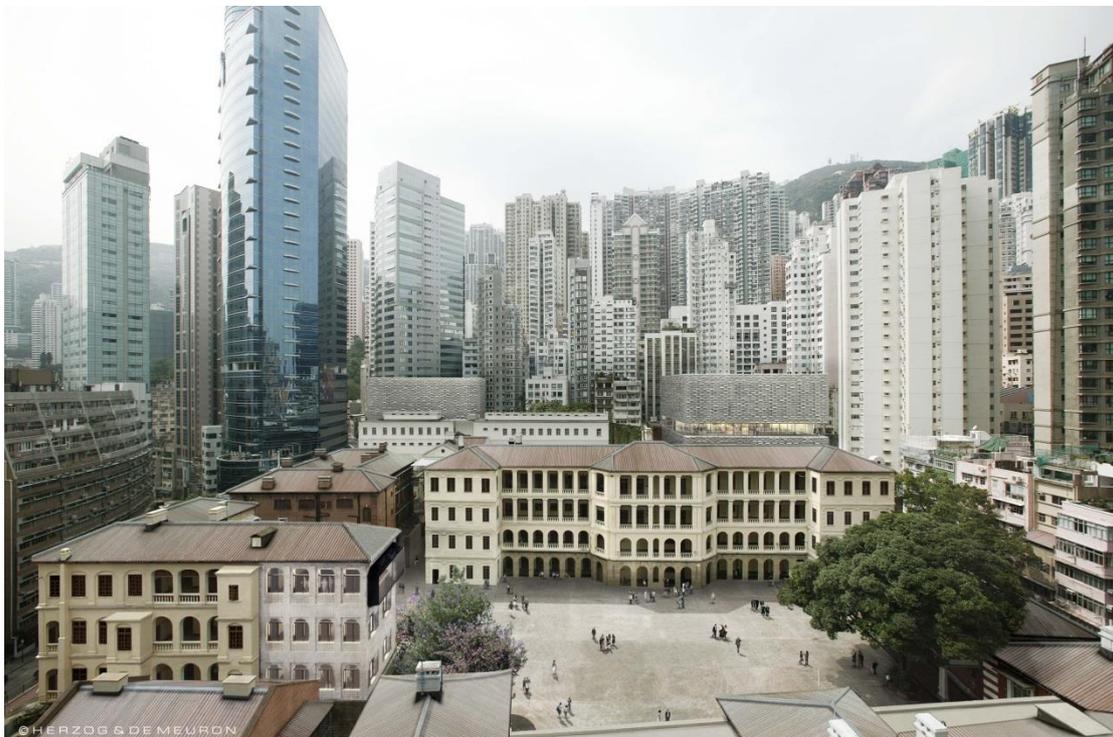
Image 2: Architect's rendering of the recovered Block 4 sitting in the Central Police Station compound
